# Manhole Inspection Summary

Manhole # S45I\_\_033MH

Insp Date: **4/24/08 10:52 AM**

**Location** Address: **2029 s castle st**

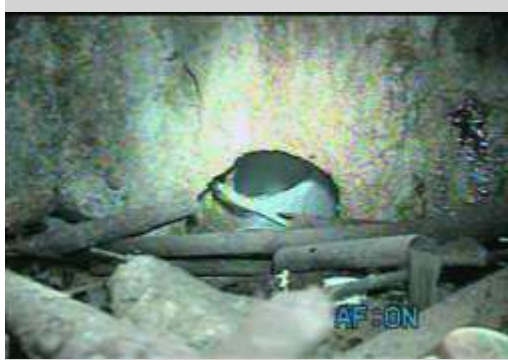
Defect 4

Condition: ☐ Sound ☒ **Cracked** ☐ Root Intrusion ☐ Loose Brick ☒ **Deteriorated**

Barrel Cracked

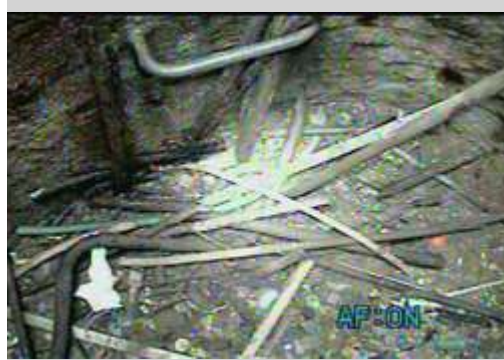
Defect 3

Condition: ☐ Sound ☐ Cracked ☐ Root Intrusion ☐ Deteriorated ☐ Leaks ☒ **Debris**

channel debris

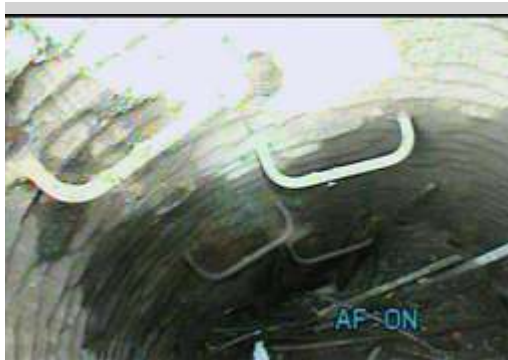
Defect 2

Infiltration: ☐ None ☐ Joint ☐ Cracks ☐ Mortar ☐ Roots ☒ **Wall**

Count: **4** Missing: **0** ☒ **Corroded**

corroded stairs, barrel cond deteriorated with infiltration from wall

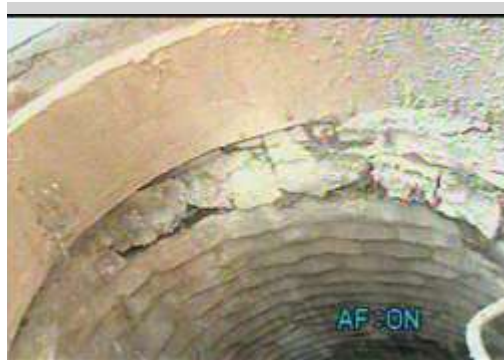
Defect 1

Condition: ☐ Sound ☐ Cracked ☐ Root Intrusion ☒ **Loose Brick** ☒ **Deteriorated**

chimney loose bricks and deteriorated, frame adjustment
